# EVALUATION OF TAPE REPAIR OF AN AUTOMOTIVE COOLING HOSE

ATS JOB # D55612

**MATERIALS TEST REPORT**

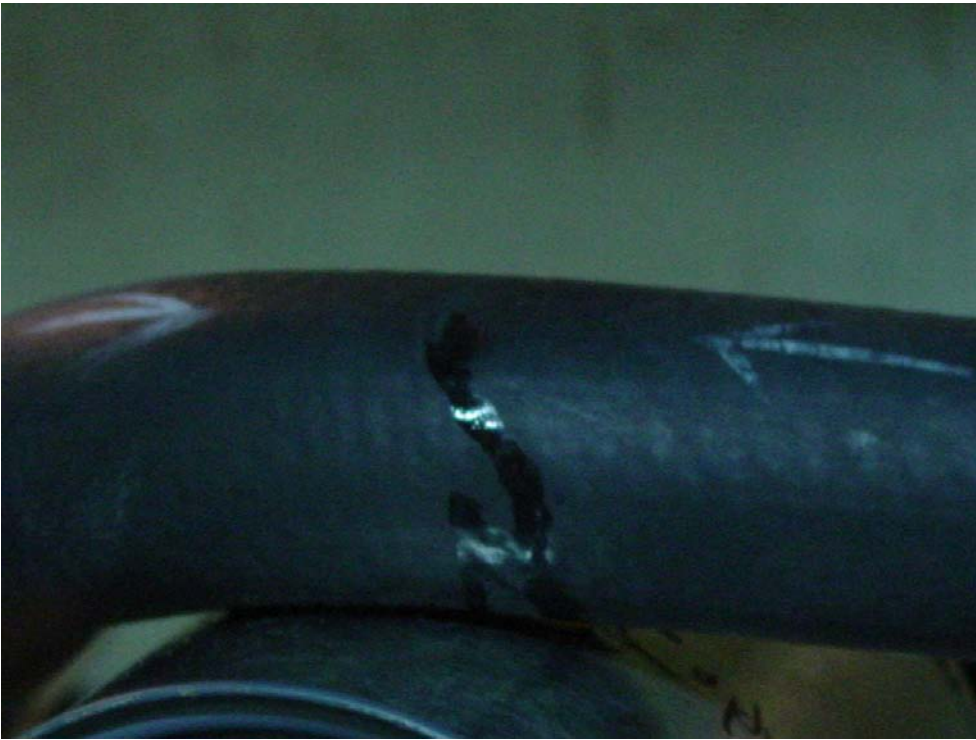
Close up showing hole in rad hose.

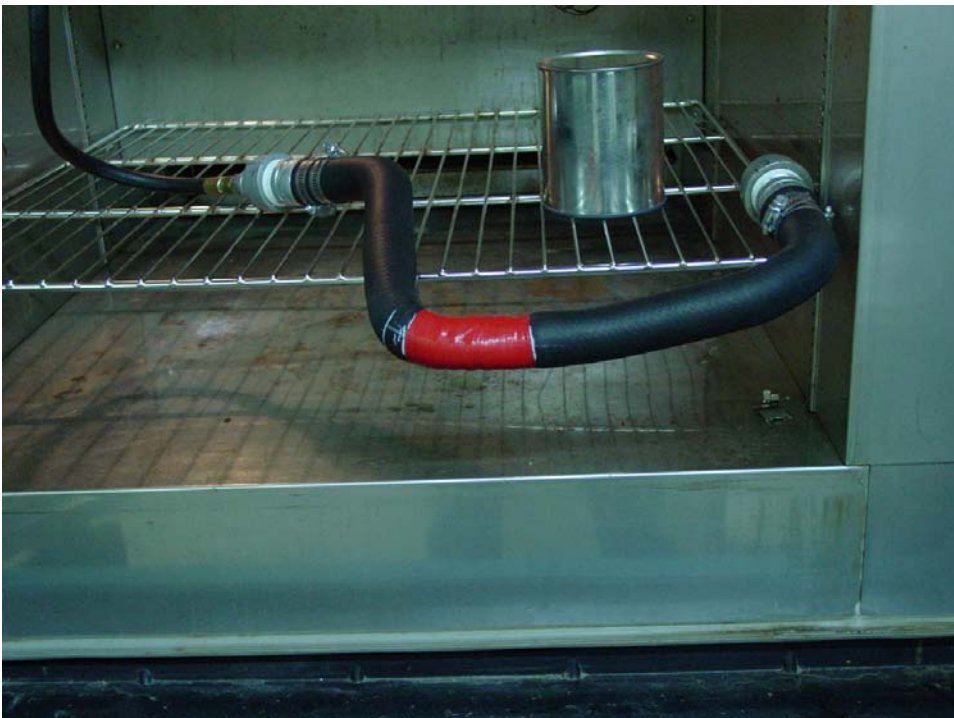
“Failure” repaired by tape under test.

A repair was made on the hole using the provided tape by the following application method: A 66 inch long section of the tape was stretched to 5/8 inch width and applied in 3 layers over a 3 inch run centered on the leak. Each lap was applied in half width (5/16 inch) overlaps. An 18 inch section was then stretched to 7/8 inch width and applied in 1 layer over the total 3 inch area. This final layer was also applied in half width (7/16 inch) overlaps (Figure 3).

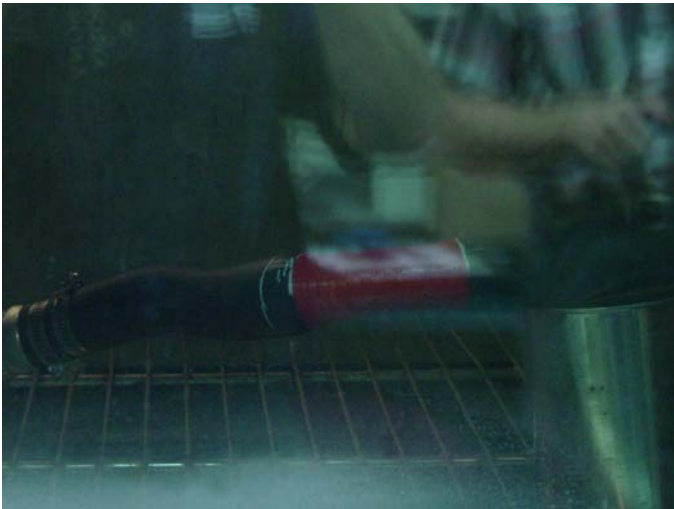
Tape wrapped over hose as seen through the test chamber.

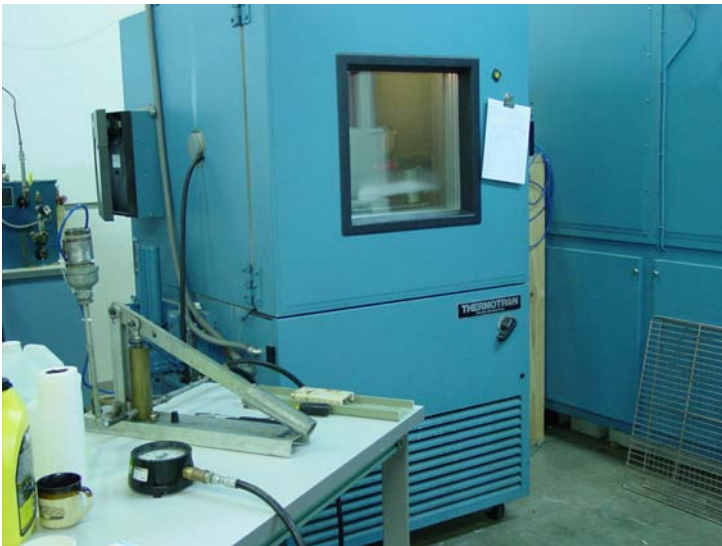
Test Chamber and test setup showing positive displacement pump and pressure gauge. Note: tape seal can be vaguely seen wrapped over hose.

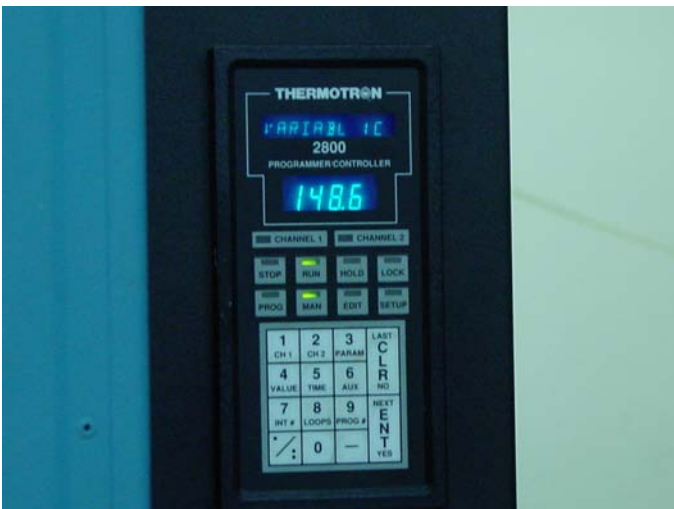
Chamber Temperature ( $^{\circ}\text{C}$ )

The environmental chamber was then closed, and the temperature raised to 299.5° F (148.6° C) (Figures 4 through 6). The test article was then subjected to the following pressures as prescribed by the customer:

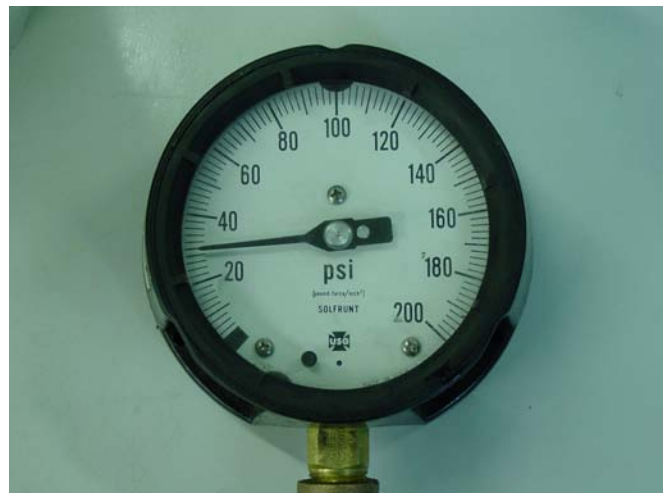
Chamber Pressure (PSI) for first hour of test

- 10 psi for 5 minutes
- 20 psi for 7 minutes
- 28 psi for 49 minutes
- 32 psi for 11 minutes
- 40 psi for 2 minutes
- 50 psi for 2 minutes
- 60 psi for 2 minutes
- 70 psi for 2 minutes
- 80 psi for 2 minutes

As 80 psi was approached the hose began to expand greatly while the repair remained virtually unchanged. The tape performed satisfactorily under pressures and temperatures well beyond that which is encountered in automotive cooling systems.
